## MARINE INVESTIGATION REPORT

M02C0011

**STRIKING**

**BY THE TUG-BARGE UNIT *PROGRESS/PITTS CARILLON***

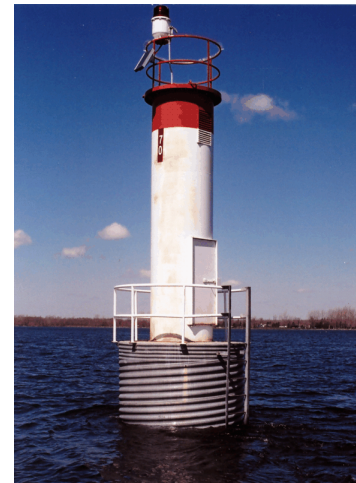
Crib light 82 is located approximately 100 m southeast of Broder Island. The fixed navigation aid is a white circular tower with a red top 10.1 m high above water level, resting on a 3.5 m diameter concrete base. The light characteristic is flashing red with a four-second interval and it has a nominal range of 4 nautical miles (see Photo 3).

**Photo 3.** Typical crib light
